5 Star Home Inspection, LLC
312 Redstone St
Las Vegas, NV 89145

Table of Contents

Property Inspected: Your address

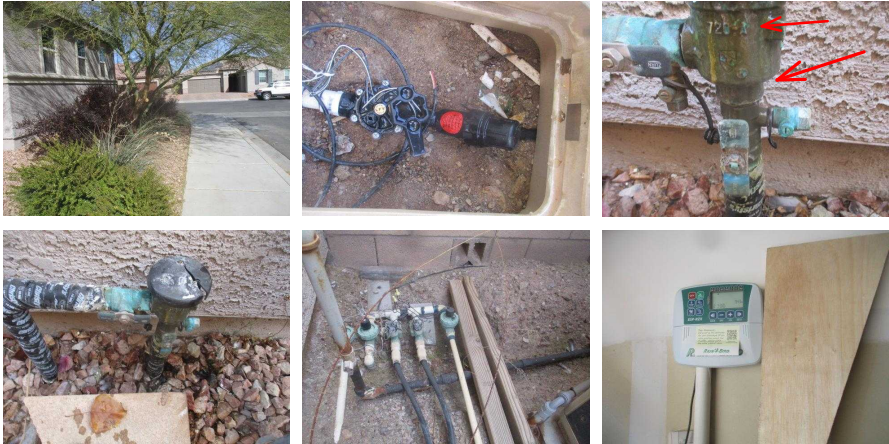
Lawn Sprinklers: (continued)

1. Lawn Sprinklers: Front and back yard The Anti Siphon Valve has a continual flowing leak.
We test sprinklers from the valve boxes only so as not to disrupt the timing of the programmed box.

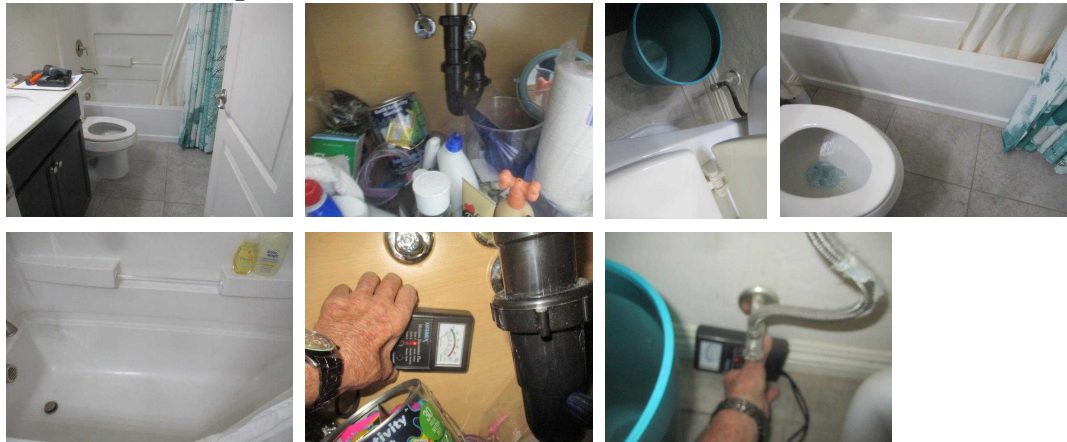
Lower Full Bath Bathroom

7. ☒ ☐ ☐ ☐ ☐ ☐ Sink/Basin: Molded single bowl
 8. ☐ ☐ ☒ ☐ ☐ ☐ Faucets/Traps: Moen fixtures with a PVC trap **Shower diverter not functioning properly, not all of the water is flowing to showerhead**

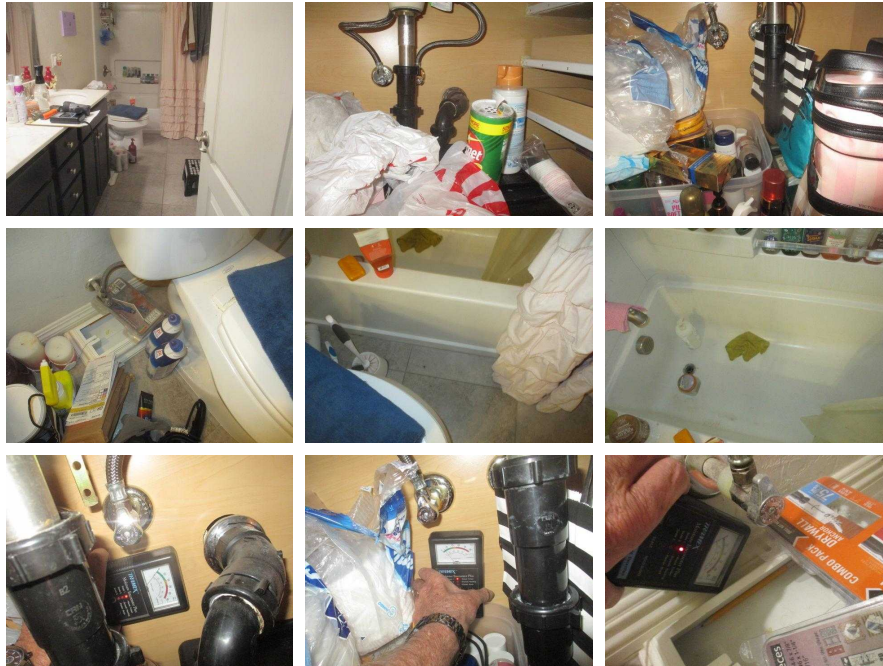
Upper Hall Bath Bathroom

15. ☒ ☐ ☐ ☐ ☐ ☐ Floor: Tile
 16. ☒ ☐ ☐ ☐ ☐ ☐ Doors: Hollow wood
 17. ☒ ☐ ☐ ☐ ☐ ☐ Electrical: 110 VAC GFCI
 18. ☒ ☐ ☐ ☐ ☐ ☐ Counter/Cabinet: Cultured Marble Cabinets have wood backing, cannot see the wall behind them
 19. ☒ ☐ ☐ ☐ ☐ ☐ Sink/Basin: Molded dual bowl
 20. ☐ ☐ ☒ ☐ ☐ ☐ Faucets/Traps: Moen fixtures with a PVC trap **Shower diverter not functioning properly, not all of the water is flowing to showerhead**

21. ☒ ☐ ☐ ☐ ☐ ☐ Tub/Surround: Fiberglass tub and fiberglass surround
22. ☒ ☐ ☐ ☐ ☐ ☐ Toilets: Vortens
23. ☒ ☐ ☐ ☐ ☐ ☐ HVAC Source: Air exchange ventilation
24. ☐ ☐ ☐ ☒ ☐ ☐ Ventilation: Electric ventilation fan **Fan inoperative**
